**Flood Control Project Maintenance
Levee Inspections**
LMA District Cover Sheet
Spring 2020 Levee Inspection Results

Sacramento River West Side Levee District

Spring 2020 Levee Inspection Results

Waterway			Bank	Unit Miles
Unit No. 01 Sacramento River			Right	49.64
	Spring (March - May)	Summer (June - August)	(September - November) Fall	Winter (December - February)
Unit Maintenance Rating (Fall Only)				
Date of Inspection	3/24/2020 - 3/24/2020			
DWR Inspector	Zach Jojola			
Accompanied By	Gary Marler RD0108

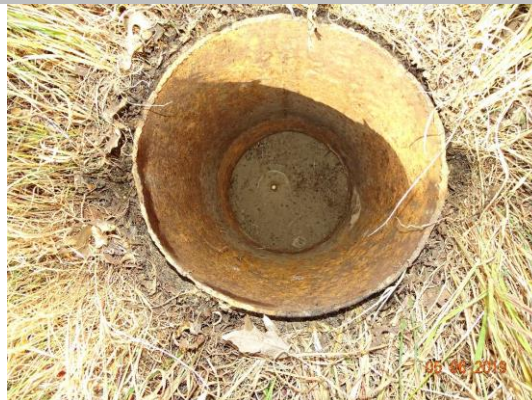
Photo 2 of 3 : UCIP_SP_2020_53978_79199.jpg

Comment Code						
Inspector Comment						
DS_ID:20255 FS_ID:53978 EP_NO: 4786 Repair Type: Non-Urgent Crossing Status: Found UCIP Comments: 05/06/2019 Crossing not in use and looks abandoned. Air release valve is silted inside a riser on WS shoulder (O.Yakimov - DWR UCIP) FIELD_STRUCT_DESC: 16-inch steel drainage pipe through the levee, 6.2 feet below the crown. One metal cutoff wall. Gate valve on the landside (LS) end. Siphon breaker on the waterside (WS) slope inside steel riser unit. Flap gate on the WS end. Bank rock revetted. (Permit No. 4786, 1964 - F. Erdman). [Additional Reference(s): DWR Levee Log, 2006]. FS Date: 5/6/2019 4:11:08 PM

Air valve is silted inside of metal riser

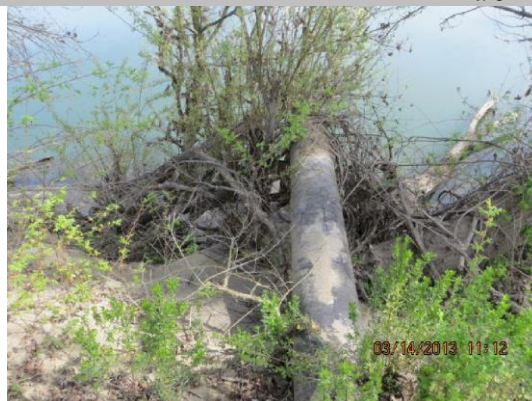
Photo 3 of 3 : UCIP_SP_2020_53978_17539.jpg

Pipe at rivers edge.

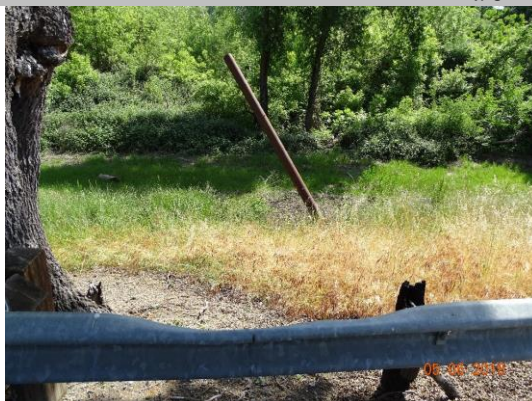
Photo 2 of 3 : UCIP_SP_2020_53980_79206.jpg

Comment Code					
Inspector Comment					
DS_ID:20256 FS_ID:53980 EP_NO: 9368 Repair Type: Urgent Crossing Status: Found UCIP Comments: 05/06/2019 Standpipe on WS slope is damaged. A tree that was located next to the stand pipe is gone. At the place of former tree roots there is a large pit hole 3x4x2 feet starting from WS levee toe going into WS slope. Missing operation wheel on gate valve off LS toe. Crossing is abandoned and needs a proper abandonment or removal. (O.Yakimov - DWR UCIP) Need to abandon pipe properly. FIELD_STRUCT_DESC: 24-inch steel irrigation pipe through the levee, 16.2 feet below the crown. Pump on the waterside (WS) bank. Gate valve on the landside (LS) end. Concrete box at the LS toe of the slope. Irrigation well 6 feet from the toe of the landward slope. (Automatic Board Order (ABO) issued as Permit No. 9368, 1974 - Fredinand Erdman). [Additional Reference(s): DWR Levee Log, 2006. USACE Sacramento O&M Manual 131, May 1960 (HLM 27.79) (standpipe on the WS)]. FS Date: 5/6/2019 8:19:13 AM

View of bent metal standpipe at WS toe

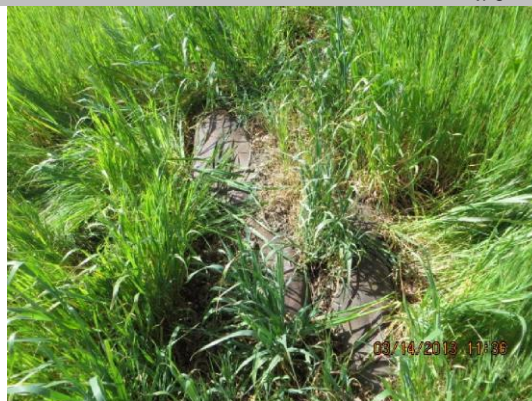
Photo 1 of 2 : UCIP_SP_2020_53981_17545.jpg

Comment Code						
Inspector Comment						
DS_ID:20416						
FS_ID:53981						
EP_NO: N/A						
Repair Type: Non-Urgent						
Crossing Status: Indicator Found						
UCIP Comments: 05/06/2019 Crossing not found. A candidate for electromagnetic survey.(O.Yakimov - DWR UCIP)						
Appears this pipe is abandoned and visible on WS slope in pieces.						
Need to verify proper abandonment.						
FIELD_STRUCT_DESC: *ABANDONED* 24-inch pipe of an unknown type and material through the levee, 6.2 feet below the crown. Pipe debris on the waterside (WS) slope. [Additional Reference(s): USACE Sacramento O&M Manual 131, May 1960 (HLM 27.79)].						
FS Date: 5/6/2019 9:13:36 AM

Pipe debris on WS slope.

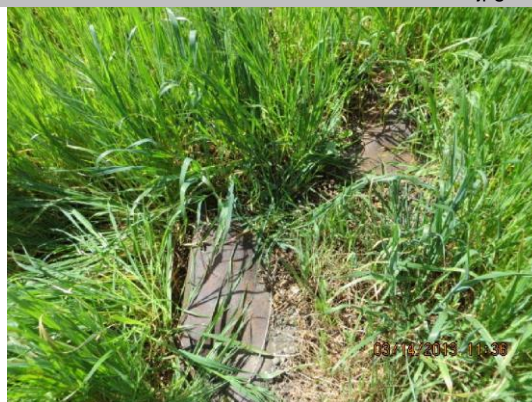
Photo 2 of 2 : UCIP_SP_2020_53981_17544.jpg

Pipe debris on WS slope.

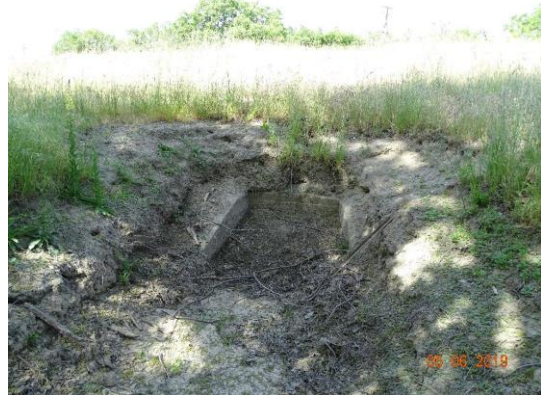
Photo 1 of 3 : UCIP_SP_2020_53982_79209.jpg

Comment Code						
Inspector Comment						
DS_ID:20257 FS_ID:53982 EP_NO: 9355 Repair Type: Non-Urgent Crossing Status: Found UCIP Comments: 05/06/2019 Inlet and outlet gates are silted. Missing handwheel on gate valve at LS toe. (O.Yakimov - DWR UCIP) Pipe needs to be properly abandoned. FIELD_STRUCT_DESC: *ABANDONED* 24-inch steel drainage pipe through the levee, 14 feet below the crown. Slide gate on the waterside (WS) end. Gate valve on the landside (LS) end. (24-inch pipe [HLM 27.89] authorized under Automatic Board Order (ABO) issued as Permit No. 9355, 1974 - Alvin Gustafson). [Additional Reference(s): DWR Levee Log, 2006. USACE Sacramento O&M Manual 131, May 1960 (HLM 27.89)]. FS Date: 5/6/2019 9:24:06 AM

Slide gate silted on WS end

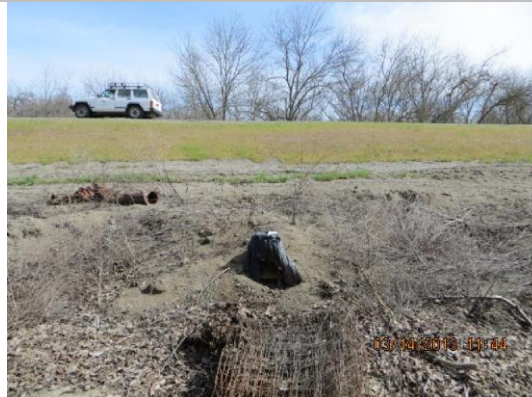
Photo 3 of 3 : UCIP_SP_2020_53982_17548.jpg

Gate valve buried on LS toe

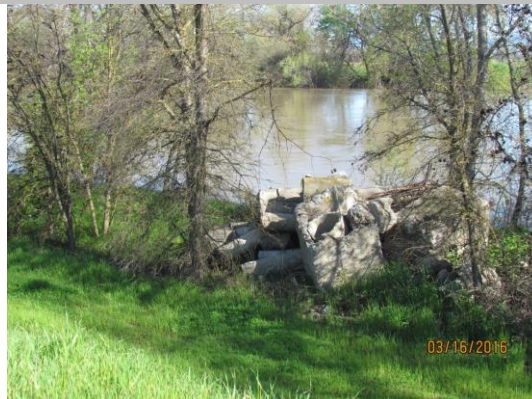
Photo 1 of 1 : SP_2020_NA0016_435_59_20200228_00017.jpg

LM Start	28.02	Rating **	M	Issue No.	59
LM End	28.02	Issue Type +	En	Location *	WS
Category	Earthen Levee			GPS Latitude/Longitude	
				Start	End
Item	Encroachments			39.040750 °	39.040750 °
				-121.835299 °	-121.835299 °
DWR ID	DWR_NA0016_01_s_2012_59				
Comment Code					
DE : Debris					
Inspector Comment					
There are piles of concrete on the waterside berm.

View of the pile of concrete on the waterward berm of the levee. Spring 2016.

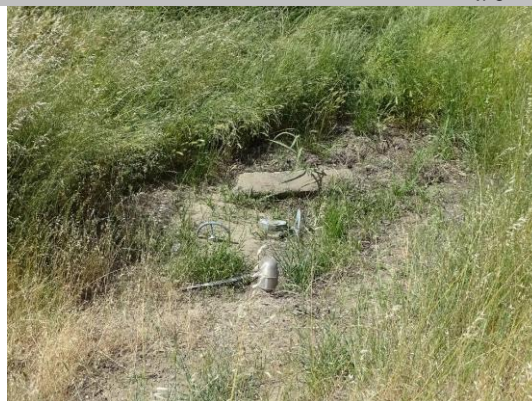
Photo 1 of 3 : UCIP_SP_2020_53983_79212.jpg

Comment Code					
Inspector Comment					
DS_ID:20258 FS_ID:53983 EP_NO: 9367 Repair Type: Non-Urgent Crossing Status: Found UCIP Comments: 05/06/2019 Closure devices located at LS toe are buried with mud that limits their operation. (O.Yakimov - DWR UCIP) FIELD_STRUCT_DESC: 14-inch irrigation pipe of an unknown material through the levee, 7.5 feet below the crown. Pump in pump house on the waterside (WS) bank. Siphon breaker inside a 24-inch corrugated metal riser unit on the landside (LS) slope. Pole on the WS shoulder. (Automatic Board Order (ABO) issued as Permit No. 9367, 1974 - Elna Schohr, Inc.). [Additional Reference(s): DWR Levee Log, 2006. USACE Sacramento O&M Manual 131, May 1960 (HLM 28.41)]. FS Date: 5/6/2019 11:22:51 AM

Closure devices at LS toe

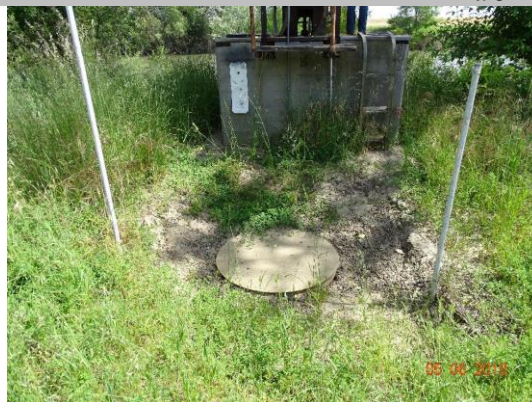
Photo 2 of 3 : UCIP_SP_2020_53983_79213.jpg

Pumping vault at riverbank

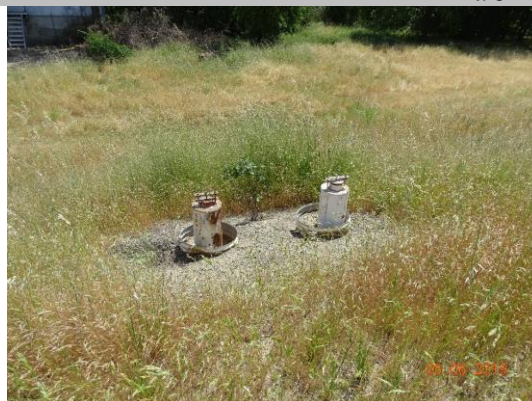
Photo 2 of 3 : UCIP_SP_2020_53985_79217.jpg

CMP riser with siphon breaker on WS slope

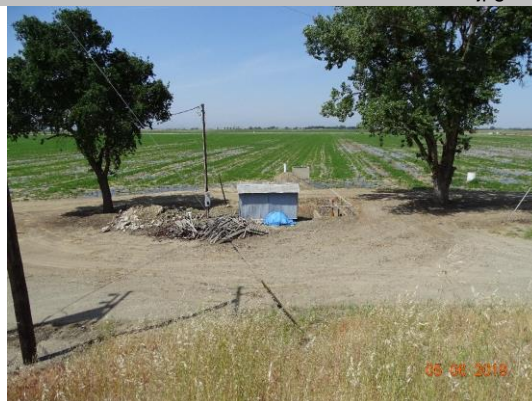
Photo 2 of 3 : UCIP_SP_2020_53986_79221.jpg

Pumphouse and sump on LS looking from levee crown

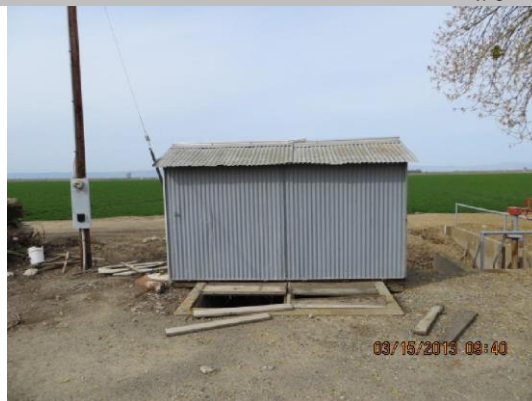
Photo 3 of 3 : UCIP_SP_2020_53986_17569.jpg

Pumphouse over sump on LS toe.

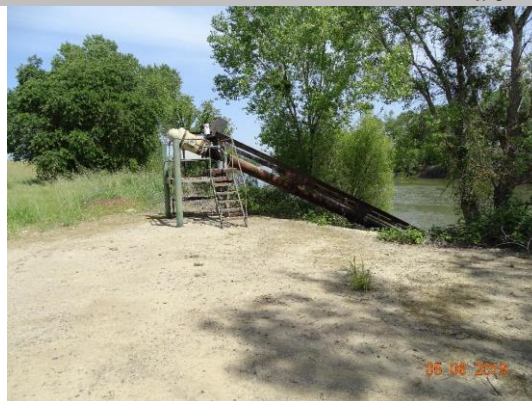
Photo 1 of 3 : UCIP_SP_2020_53987_79225.jpg

DS_ID:20340
 FS_ID:53987
 EP_NO: 9358
 Repair Type: Non-Urgent
 Crossing Status: Found
 UCIP Comments: 05/06/2019 No issues recorded during inspection.
 Observed pipe running - no leaks. (O.Yakimov - DWR UCIP)
 FIELD_STRUCT_DESC: 24-inch steel irrigation pipe through the levee, 24.5 feet below the crown. Screw gate in pump house on the waterside (WS) berm. 24-inch corrugated metal riser unit on the WS berm where slant pump on steel structure at water's edge ties into this pipe (butterfly valve at junction). Butterfly valve in concrete sump at landside (LS) toe. Overhead power line crosses the levee. Pole on the LS shoulder. (one 12-inch, one 16-inch, and one 24-inch pipes [HLM 29.02] authorized under Automatic Board Order (ABO) issued as Permit No. 9358, 1974 - Crocker National Bank (Trustee)). [Additional Reference(s): USACE Sacramento O&M Manual 131, May 1960 (HLM 29.02)].
 FS Date: 5/6/2019 2:38:58 PM

View of slant pump on WS berm

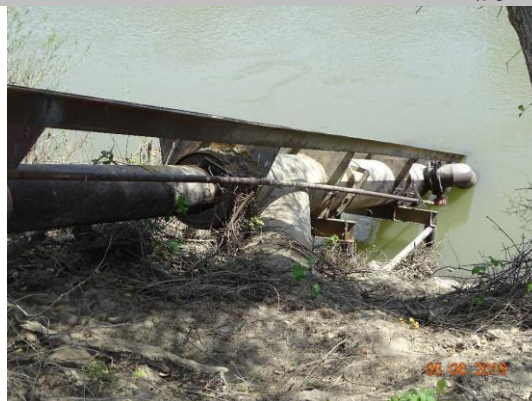
Photo 2 of 3 : UCIP_SP_2020_53987_79227.jpg

Intake pipe at riverbank

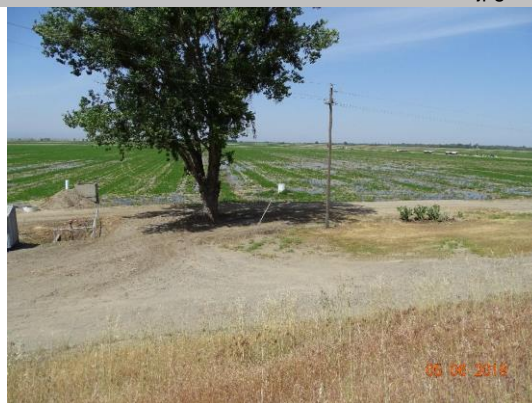
Photo 3 of 3 : UCIP_SP_2020_53987_79226.jpg

View of appurtenances on LS looking from levee crown

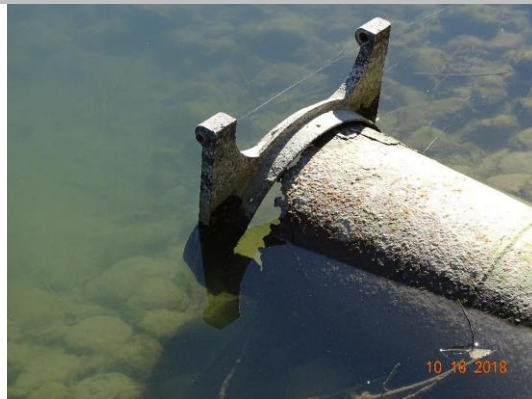
Photo 1 of 3 : UCIP_SP_2020_53988_78171.jpg

Comment Code						
Inspector Comment						
DS_ID:20311 FS_ID:53988 EP_NO: 12609 Repair Type: Urgent Crossing Status: Found UCIP Comments: 05/06/2019 No changes from last inspection. Pipe on riverbank is under water. (O.Yakimov - DWR UCIP)10/16/2018 Water level is low enough to see that flap gate on WS end is missing. In addition, pipe has corroded through around flap gate frame. Unable to locate pipe inlet on LS. Crossing should be abandoned properly. Recommend internal pipe inspection to determine pipe integrity through levee. (O.Yakimov - DWR)09/23/2016 - pipe outlet still submerged, but visible enough to determine that flap gate is still missing. Appurtenances on the LS of the levee do not appear to be associated with this pipe. There is no visible location for collection of drainage water to go through the outfall. As a result, it does not appear that this pipe is in use. (T. Hatch/UCIP) 09/01/201 - pipe outlet was submerged at time of inspection. Unable to view if flap gate had been replaced. Otherwise, conditions do not appear to be significantly different from previous inspection. (T. Hatch/UCIP) 03/15/201- Flap gate missing from waterward end of pipe. (W. Wylie/UCIP) FIELD_STRUCT_DESC: 24-inch steel outfall drainage pipe through the levee, 4.1 feet below the crown. Siphon breaker inside an 18-inch concrete riser unit on the waterside (WS) shoulder. Flap gate on the WS toe. Rock protection along the riverbank at the WS toe. (Permit No. 12609, 1978 - Jack E. Gross). [Additional Reference(s): DWR Levee Log, 2006]. FS Date: 5/6/2019 3:02:33 PM

Missing flap gate on WS end. Pipe is corroded through.

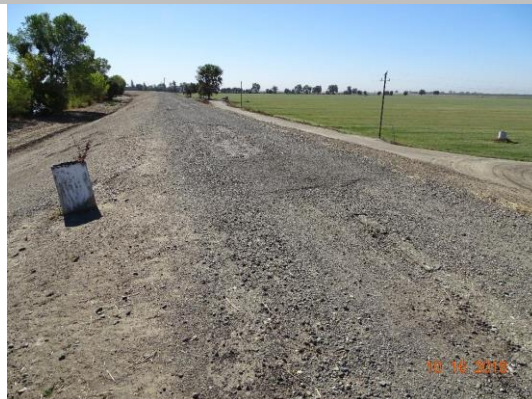
Photo 2 of 3 : UCIP_SP_2020_53988_78168.jpg

View of levee crown at crossing.

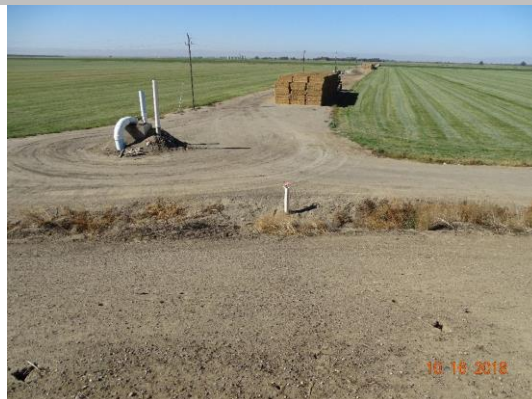
Photo 3 of 3 : UCIP_SP_2020_53988_78169.jpg

Pipe is not found on LS. Appurtenances on LS are not associated with this crossing.

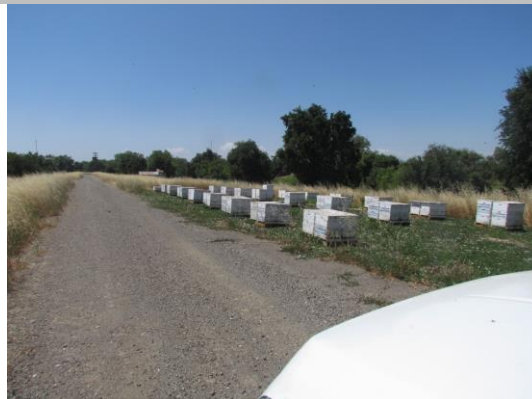
Photo 1 of 1 : SP_2020_NA0016_435_99_20200228_00031.jpg

LM Start	31.28	Rating **	M	Issue No.	99
LM End	31.28	Issue Type +	En	Location *	WS
Category	Earthen Levee			GPS Latitude/Longitude	
				Start	End
Item	Encroachments			39.066921 °	39.066921 °
				-121.864077 °	-121.864077 °
DWR ID	DWR_NA0016_01_s_2015_99				
Comment Code					
EQ : Equipment					
Inspector Comment					
Bee hives are located on the waterside shoulder.

View of the beehives on the shoulder of the waterward side of the levee looking upstream. Spring 2015.

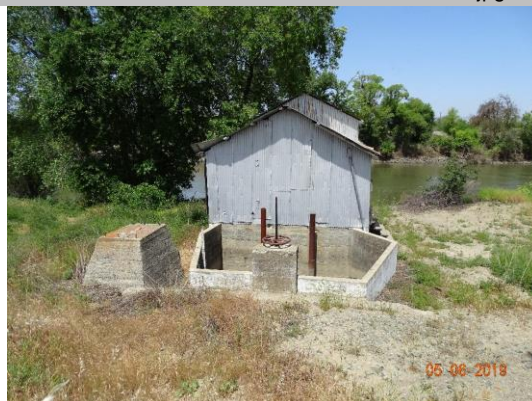
Photo 1 of 3 : UCIP_SP_2020_54143_79707.jpg

Comment Code						
Inspector Comment						
DS_ID:20261 FS_ID:54143 EP_NO: 9358 Repair Type: Non-Urgent Crossing Status: Found UCIP Comments: 05/06/2019 Pipe is running, no leaks observed. (O.Yakimov - DWR UCIP) FIELD_STRUCT_DESC: 3-foot by 3-foot reinforced concrete box irrigation culvert through the levee, 18 feet below the crown. Slide gate on the waterside (WS) inside a concrete surge box. Pump house on the WS berm. 5-foot by 7-foot concrete distribution box at the landside (LS) toe. Overhead power line crosses the levee. Pole on the WS shoulder (3-foot by 3-foot culvert [HLM 31.78] Automatic Board Order (ABO) issued as Permit No. 9358, 1974 - Crocker National Bank (Trustee)). [Additional Reference(s): USACE Sacramento O&M Manual 131, May 1960 (HLM 31.78)]. FS Date: 5/6/2019 3:43:23 PM

Pump house on WS

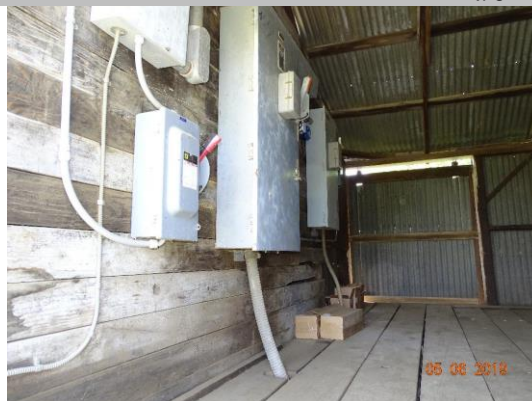
Photo 2 of 3 : UCIP_SP_2020_54143_79709.jpg

View inside of pumphouse

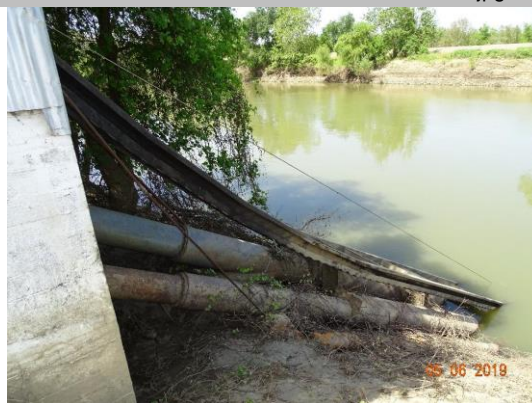
Photo 3 of 3 : UCIP_SP_2020_54143_79710.jpg

Pipes at river's edge

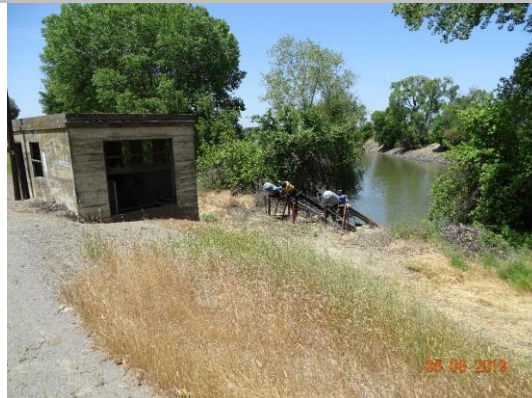
Photo 1 of 3 : UCIP_SP_2020_54144_79713.jpg

Comment Code						
Inspector Comment						
DS_ID:20262 FS_ID:54144 EP_NO: 9338 Repair Type: Non-Urgent Crossing Status: Found UCIP Comments: 05/06/2019 Power line for this group of pumps that has been run underground to service box on WS shoulder at LM 31.63 should be recorded as a separate crossing. (O.Yakimov - DWR UCIP) 03/15/2013 Pipe leaking at intake pipe on rivers edge below pump FIELD_STRUCT_DESC: 24-inch steel irrigation pipe through the levee, 24 feet below the crown. Slide gate in abandoned concrete pump house on the waterside (WS) slope. Three slant pumps mounted on a pile structure on the WS bank. 30-inch concrete pipe under the highway on the landside (LS). 48-inch steel riser unit on the LS of the highway. Overhead high tower power line crosses the levee. Power line has been run underground to service box on WS shoulder at LM 31.63. Ramps on both slopes. (Automatic Board Order (ABO) issued as Permit No. 9338, 1974 - Julie Ann Steidlmayer). [Additional Reference(s): DWR Levee Log, 2006. USACE Sacramento O&M Manual 131, May 1960 (HLM 32.02)]. FS Date: 5/6/2019 4:10:23 PM

Concrete block house with slide gateinside

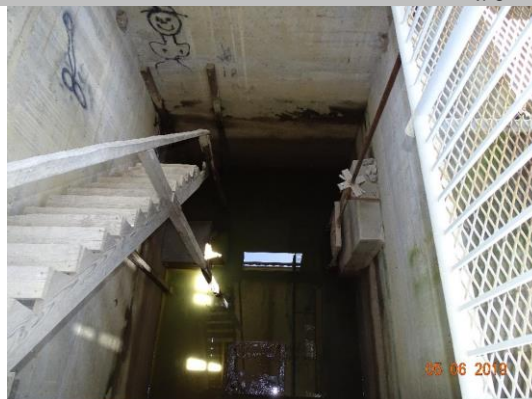
Photo 2 of 3 : UCIP_SP_2020_54144_79714.jpg

Slide gate inside concrete blockhouse

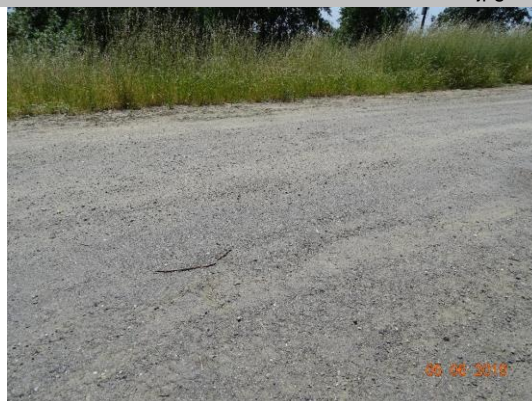
Photo 3 of 3 : UCIP_SP_2020_54144_79719.jpg

Levee crown at crossing

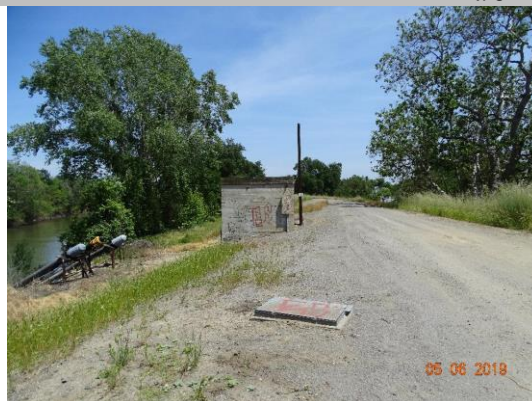
Photo 1 of 3 : UCIP_SP_2020_56346_83833.jpg

LM Start	31.63	Rating **	M	Issue No.	1694
LM End	31.63	Issue Type +	En	Location *	
Category	Supplemental			GPS Latitude/Longitude	
				Start	End
Item	DWR UCIP Field Study			39.066187 °	39.066187 °
				-121.870438 °	-121.870438 °
DWR ID	25588				
Comment Code					
Inspector Comment					
DS_ID:25588 FS_ID:56346 EP_NO: N/A Repair Type: Non-Urgent Crossing Status: Found UCIP Comments: 05/06/2019 No permit has been found authorizing this pipe through the levee. (O.Yakimov - DWR UCIP) FIELD_STRUCT_DESC: Electrical conduit of unknown diameter through the levee at unknown depth below crown. Conduit comes from a junction pole on LS to an electric box on waterside shoulder. Crossing is located next to an abandoned pumphouse where 3 slant pumps at riverbank are installed (LM 31.614 DSID 20262). No permit available. FS Date: 5/6/2019

View of levee crown at the crossing

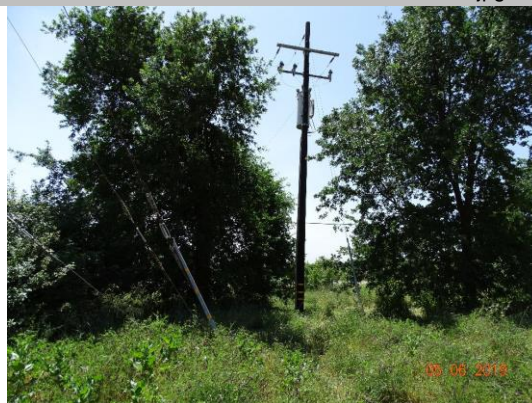
Photo 2 of 3 : UCIP_SP_2020_56346_83829.jpg

Overview of junction pole on LS

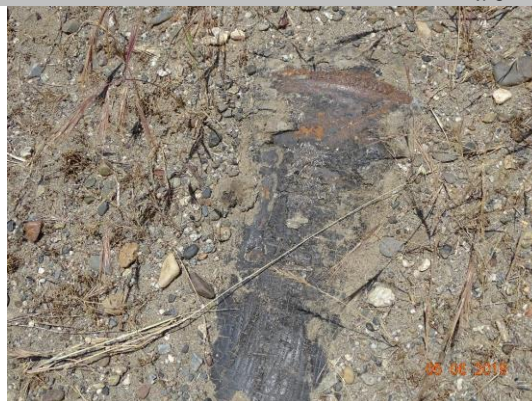
Photo 2 of 3 : UCIP_SP_2020_54146_79726.jpg

DS_ID:20263
FS_ID:54146
EP_NO: 1755A
Repair Type: Non-Urgent
Crossing Status: Found
UCIP Comments: 05/06/2019 Steel riser on WS berm is damaged. Portion of pipe is visible on LS slope. It gets impacted every time vegetation control is performed. (Special condition twenty of permit 1755-A hasn't been met. Pipe needs to be buried at least 12 inches in the levee slope.) (O.Yakimov - DWR UCIP)
FIELD_STRUCT_DESC: 18-inch steel irrigation pipe through the levee, 4 feet below the crown. Slant pump on the waterside (WS) bank. Siphon breaker inside a 12-inch steel riser unit on the WS shoulder. Pipe may terminate inside an 18-inch concrete riser on the landside (LS) toe. (Permit No. 1755-A, 1979 - Julie Ann Steidlmayer). (Replaced 18-inch steel pipe installed under Permit No. 1755, 1953 - Pete Andreotti). [Additional Reference(s): DWR Levee Log, 2006].
FS Date: 5/6/2019 8:27:11 AM

Portion of pipe is visible on LS slope

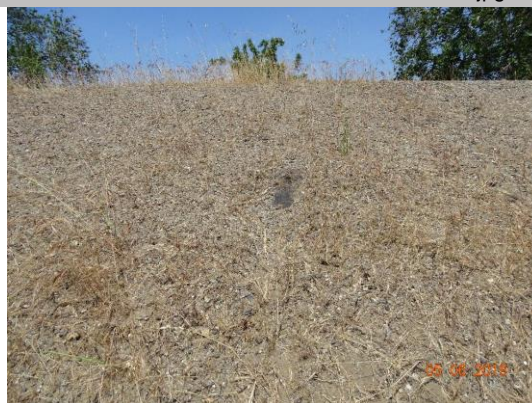
Photo 3 of 3 : UCIP_SP_2020_54146_79727.jpg

View of LS slope

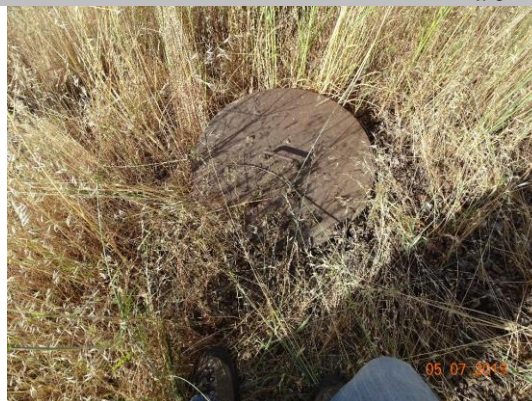
Photo 1 of 3 : UCIP_SP_2020_54148_79730.jpg

Comment Code						
Inspector Comment						
DS_ID:20304 FS_ID:54148 EP_NO: 9374 Repair Type: Non-Urgent Crossing Status: Indicator Found UCIP Comments: 05/06/2019 Crossing looks abandoned, so needs a proper abandonment or removal. (DWR UCIP O.Yakimov)03/15/2013 Need to verify type of abandonment FIELD_STRUCT_DESC: *ABANDONED* 2 of 4: 4-inch irrigation pipe of an unknown material through the levee, 6.5 feet below the crown. Gate valve on the waterside (WS) end. Siphon breaker inside a 24-inch corrugated metal riser unit on the landside (LS) slope. 4-foot by 4-foot concrete distribution box on the south side of Highway 45 at the LS toe. (Automatic Board Order (ABO) issued as Permit No. 9374, 1974 - Richard H. Moore). [Additional Reference(s): DWR Levee Log, 1980. USACE Sacramento O&M Manual 131, May 1960 (HLM 32.68)]. FS Date: 5/6/2019 1:42:33 PM

CMP riser on LS slope

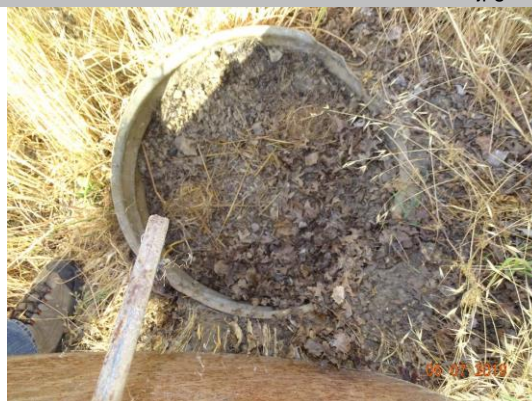
Photo 2 of 3 : UCIP_SP_2020_54148_79731.jpg

Riser is filled with soil

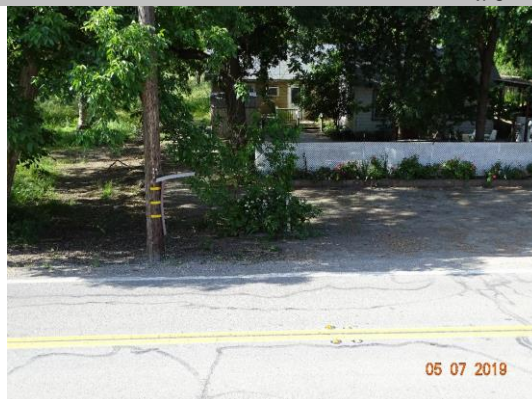
Photo 3 of 3 : UCIP_SP_2020_54148_79732.jpg

LS berm where 4x4 concrete box is located

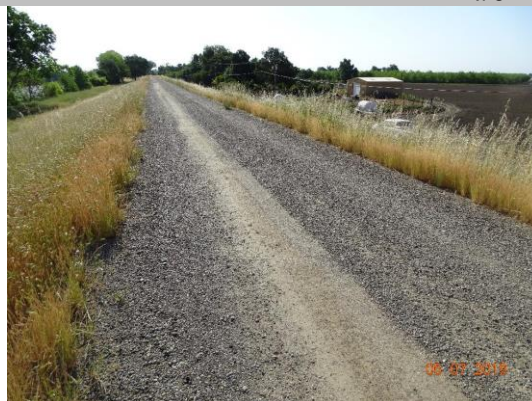
Photo 1 of 3 : UCIP_SP_2020_54149_79734.jpg

DS_ID:20264
FS_ID:54149
EP_NO: 9339
Repair Type: Non-Urgent
Crossing Status: Found
UCIP Comments: 05/07/2019 Electric motor is taken off its platform at slant pump on WS berm. Bare wires coming off a conduit near electric box on WS berm. Concrete standpipe is broken at ground level near distribution box on LS that poses fall hazard to the crossing.
(O.Yakimov - DWR UCIP)
FIELD_STRUCT_DESC: 24-inch corrugated metal irrigation pipe through the levee, 21 feet below the crown. Slide gate inside a concrete box on the waterside (WS) berm. Slant pump on the WS bank. Pipe discharges into a 7-foot by 9-foot concrete box across the county road. Service pole and switch panel on the WS berm. (Automatic Board Order (ABO) issued as Permit No. 9339, 1974 - Allen Moore).
[Additional Reference(s): DWR Levee Log, 2006. USACE Sacramento O&M Manual 131, May 1960 (HLM 32.87)].
FS Date: 5/7/2019 2:32:26 PM

Levee crown at crossing

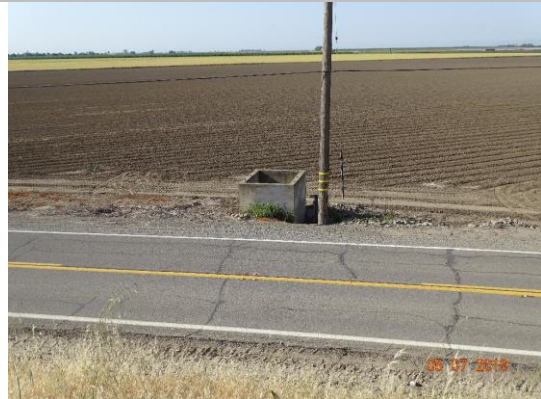
Photo 2 of 3 : UCIP_SP_2020_54149_79735.jpg

7X9-foot concrete distribution boxoff LS toe

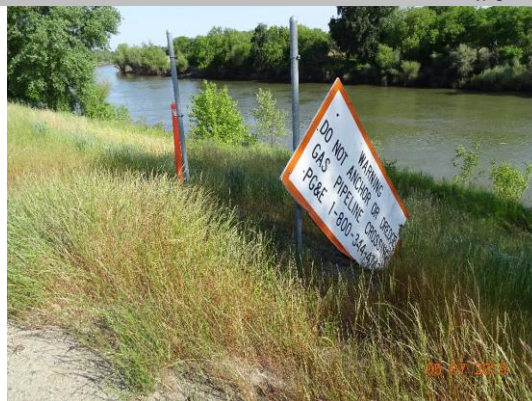
Photo 1 of 3 : UCIP_SP_2020_54150_79742.jpg

Comment Code						
Inspector Comment						
DS_ID:20265 FS_ID:54150 EP_NO: 3800 Repair Type: Non-Urgent Crossing Status: Found UCIP Comments: 05/07/2019 Record updated from No Action Needed to Non-Urgent. Need to obtain records from owner to determine status of crossing. Sign needs to be put back on a pole. (O.Yakimov - DWR UCIP) FIELD_STRUCT_DESC: 20-inch steel gas pipeline through the levee, 3 feet below the crown. Sign and marker located on waterside (WS) shoulder. Shutoff valve located 70 feet south of landside (LS) toe. (20-inch gas line authorized under permit No. 3800, 1961 - Pacific Gas and Electric [PG&E]). [Additional Reference(s): DWR Levee Log, 2006, HLM 32.98]. FS Date: 5/7/2019 3:19:27 PM

Sign and marker on WS shoulder

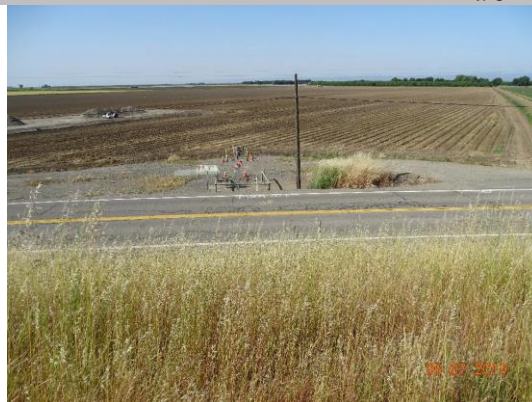
Photo 2 of 3 : UCIP_SP_2020_54150_79743.jpg

Shutoff valve 70-feet south of LS toe

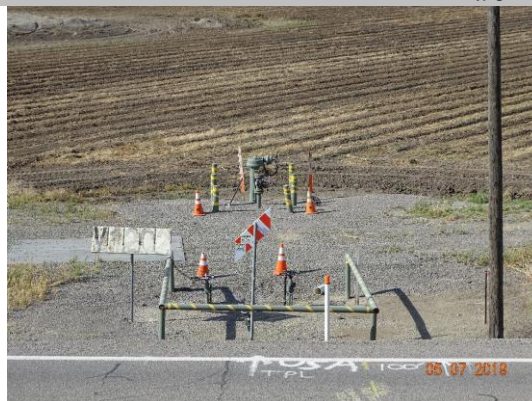
Photo 3 of 3 : UCIP_SP_2020_54150_79744.jpg

Gas line marker and shutoff valve

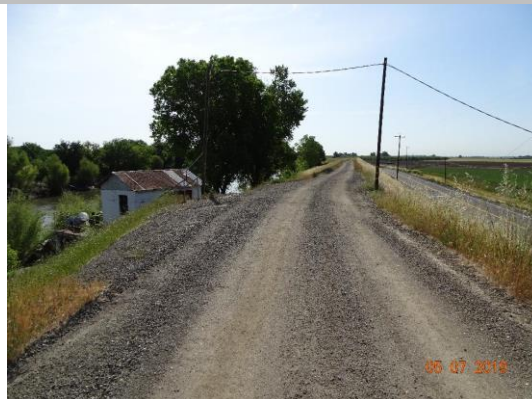
Photo 1 of 3 : UCIP_SP_2020_54152_83370.jpg

Comment Code					
Inspector Comment					
DS_ID:20266 FS_ID:54152 EP_NO: N/A Repair Type: Non-Urgent Crossing Status: Found UCIP Comments: 05/07/2019 Record updated from No Action Needed to Non-Urgent, no primary permit available. Pipe is running. No leaks detected. (O.Yakimov - DWR UCIP)03/15/2013 Good candidate for video inspection. FIELD_STRUCT_DESC: 24-inch reinforced concrete irrigation pipe through the levee, 17 feet below the crown. Two slant pumps mounted on a steel structure on the bank. Screw gate in a concrete pump house at the waterside (WS) toe. 5-foot by 5-foot concrete distribution box at the landside (LS) toe. Overhead power line crosses the levee. Pole on the LS shoulder. Pole at the WS toe. (Maintenance of existing 24-inch pipe partially encased in concrete authorized under permit No. 917, 1943 - Hoffman, Beckley, Poundstone & Richey. Related permit No. 1938, 1954 - PG&E, for power pole line extension). [Additional Reference(s): DWR Levee Log, 2006 (HLM 33.18). USACE Sacramento O&M Manual 131, May 1960 (HLM 33.18, listed as 24-inch single pipe with gate and pumphouse on waterside)]. FS Date: 5/7/2019 4:01:29 PM

Levee crown at the crossing

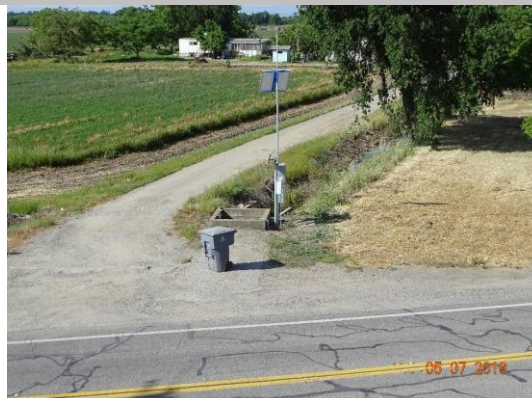
Photo 2 of 3 : UCIP_SP_2020_54152_83371.jpg

View of LS looking from levee crown

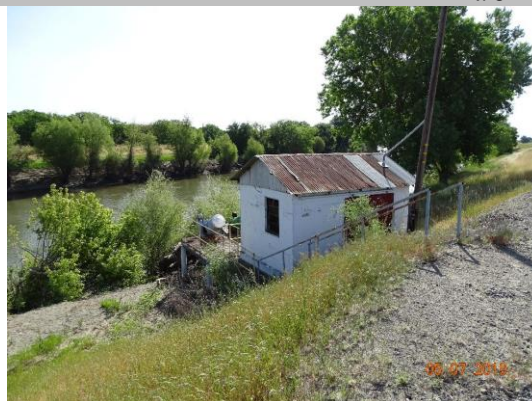
Photo 3 of 3 : UCIP_SP_2020_54152_83372.jpg

View of pumphouse on WS berm looking from levee crown

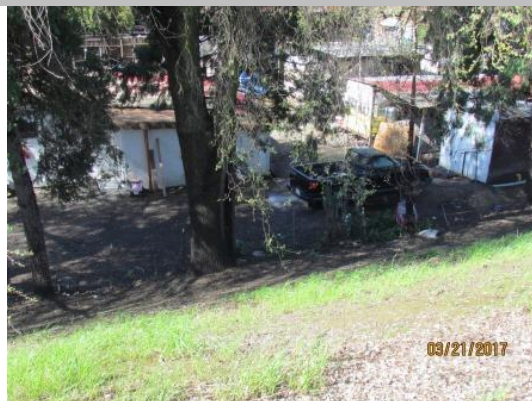
Photo 1 of 1 : SP_2020_NA0016_435_43_20200228_00014.jpg

LM Start	32.97	Rating **	M	Issue No.	43
LM End	32.97	Issue Type +	En	Location *	LS
Category	Earthen Levee			GPS Latitude/Longitude	
				Start	End
Item	Encroachments			39.074346 °	39.074346 °
				-121.892048 °	-121.892048 °
DWR ID	DWR_NA0016_01_s_2019_43				
Comment Code					
FE : Fence					
Inspector Comment					
Fence is blocking access on the landside toe.

View of fence along landside levee toe. Spring 2017.

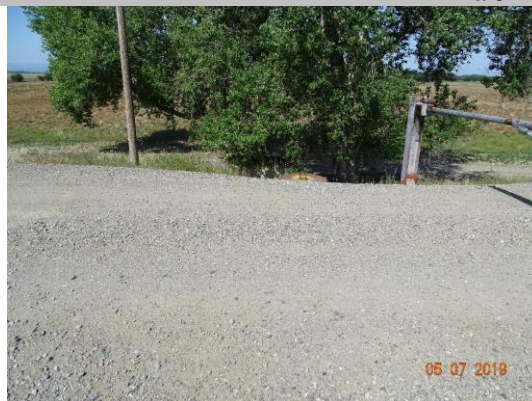
Photo 1 of 3 : UCIP_SP_2020_54156_79754.jpg

DS_ID:20268
FS_ID:54156
EP_NO: 9364A
Repair Type: Non-Urgent
Crossing Status: Found
UCIP Comments: 05/07/2019 This pipe is a candidate for internal video inspection. (O.Yakimov - DWR UCIP)03/18/2013 Pipe rusted through at concrete distribution box. May be indicator of pipe condition through levee.
FIELD_STRUCT_DESC: 1 of 4: 16-inch steel irrigation pipe through the levee, 6.3 feet below the crown. Pump in pump house on the waterside (WS) end. Siphon breaker in a 36-inch steel riser unit on the landside (LS) slope. Discharges into a 5-foot by 9-foot concrete distribution box at the LS toe. (Automatic Board Order (ABO) issued as Permit No. 9364-A, 1974 - Alice Steidlmayer). (Installed by the United States Army Corp of Engineers, 1945). [Additional Reference(s): DWR Levee Log, 2006. USACE Sacramento O&M Manual 131, May 1960 (HLM 34.46)].
FS Date: 5/7/2019 8:34:43 AM

Levee crown at crossing

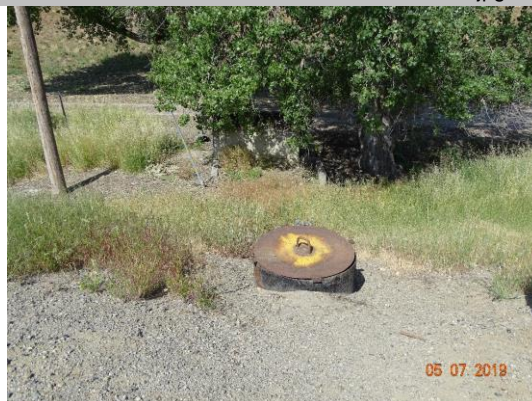
Photo 2 of 3 : UCIP_SP_2020_54156_79750.jpg

Air vent in 36-inch steel riser on LS shoulder

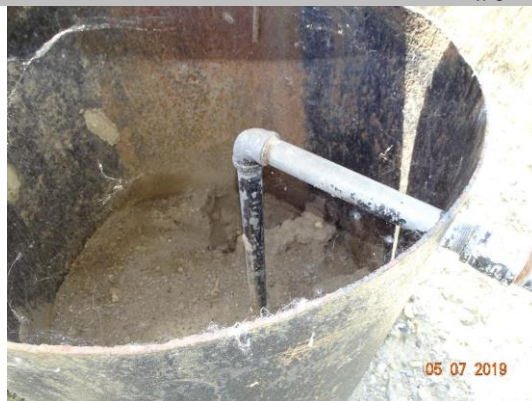
Photo 3 of 3 : UCIP_SP_2020_54156_79751.jpg

Air vent comes out of steel riser

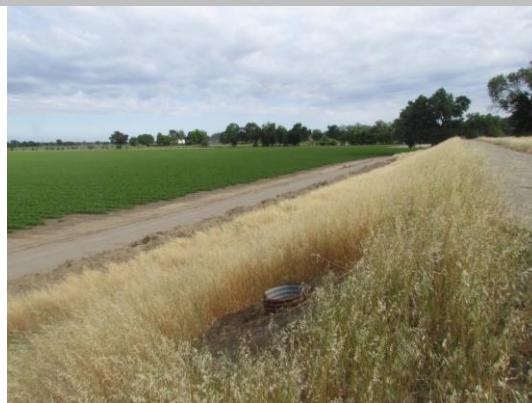
Photo 1 of 1 : SP_2020_NA0016_435_100_20200228_00032.jpg

LM Start	34.01	Rating **	M	Issue No.	100
LM End	34.07	Issue Type +	En	Location *	LS
Category	Earthen Levee			GPS Latitude/Longitude	
				Start	End
Item	Encroachments			39.087176 °	39.088099 °
				-121.896480 °	-121.896498 °
DWR ID	DWR_NA0016_01_f_2018_100				
Comment Code					
DT : Ditch					
Inspector Comment

View of the ditch at the landward side of the levee looking upstream. Spring 2015.

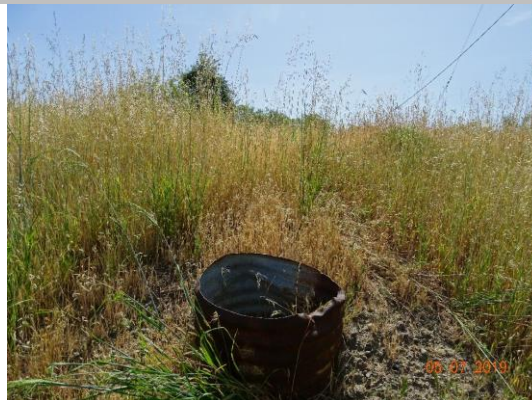
Photo 2 of 3 : UCIP_SP_2020_54157_79755.jpg

Comment Code						
Inspector Comment						
DS_ID:20269 FS_ID:54157 EP_NO: 9364A Repair Type: Non-Urgent Crossing Status: Indicator Found UCIP Comments: 05/07/2019 Abandoned crossing. Needs to be properly abandoned or removed. (O.Yakimov - DWR UCIP) FIELD_STRUCT_DESC: *ABANDONED* 2 of 4: 16-inch steel irrigation pipe through the levee, 6.5 feet below the crown. Plugged on the waterside (WS) end. Siphon breaker in a 24-inch corrugated metal riser unit on the landside (LS) shoulder (Automatic Board Order (ABO) issued as Permit No. 9364-A, 1974 - Alice Steidlmayer). [Additional Reference(s): DWR Levee Log, 2006. USACE Sacramento O&M Manual 131, May 1960 (HLM 34.47)]. FS Date: 5/7/2019 11:18:46 AM

24-inch CMP riser on LS shoulder

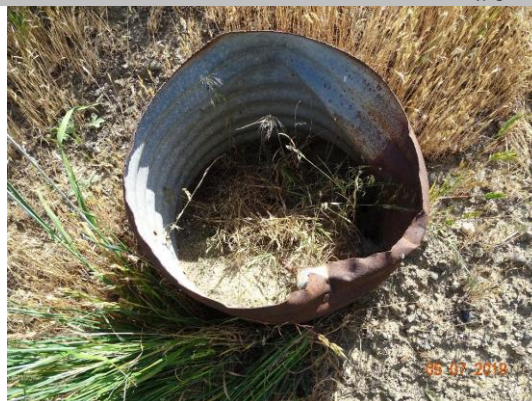
Photo 3 of 3 : UCIP_SP_2020_54157_79756.jpg

View inside of CMP riser

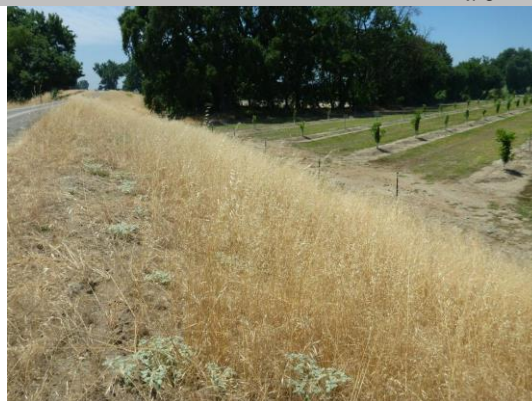
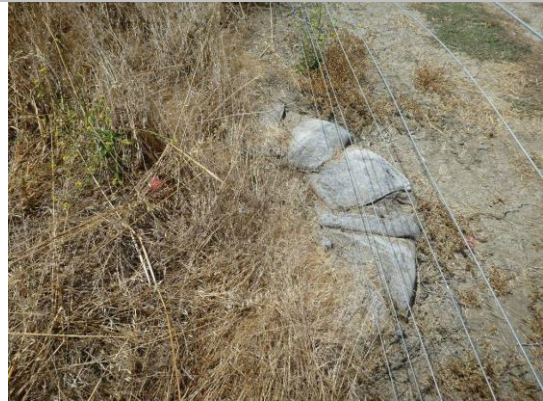
LM Start	34.24	Rating **	A/W	Issue No.	123
LM End	34.73	Issue Type +	Ob	Location *	LS
Category	Earthen Levee			GPS Latitude/Longitude	
				Start	End
Item	Seepage / Sandboils			39.090485 °	39.095628 °
				-121.895670 °	-121.897461 °
DWR ID	DWR_NA0016_01_s_2020_123				
Comment Code					
Inspector Comment					
Seepage berm planned under PL84-99.					
Site ID No:185					
Site Designation:SRWLD-03					
Ste ID No:184					
Site Designation:SRWLD-02

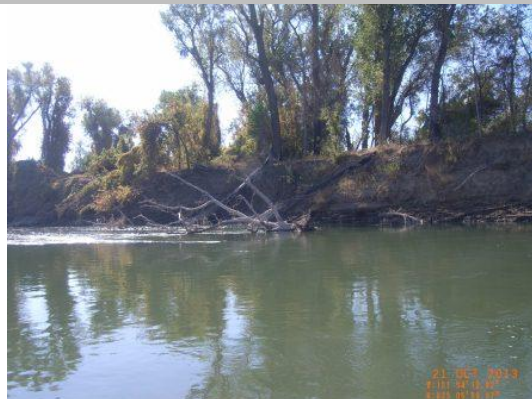
Photo 1 of 1 : SP_2020_NA0016_435_94_20200228_00027.jpg

LM Start	35.23	Rating **	A/W	Issue No.	94
LM End	35.33	Issue Type +	Ma	Location *	WS
Category	Supplemental			GPS Latitude/Longitude	
				Start	End
Item	2017 USACE Erosion Survey			39.099482 °	39.100836 °
				-121.903430 °	-121.904320 °
DWR ID	DWR_NA0016_01_f_2018_94				
Comment Code					
Inspector Comment					
2017 Site ID: SAC 127.9 R Status: Eroding 2017 Field Notes: fresh erosion at lower slope. Site History: 1997 - Major scour off the downstream end of existing rock, creating a scour pocket where the levee starts diverging from the bankline. 2000 - Some minor erosion, 20 ft deep hole at downstream end. 2004 - Small amount of new erosion. 2010 - Bad transition off downstream end of rock revetment, some new erosion. 2012 - Site extended downstream, minor new erosion. 2013- Minor new erosion. 2016 - Fresh erosion at toe.

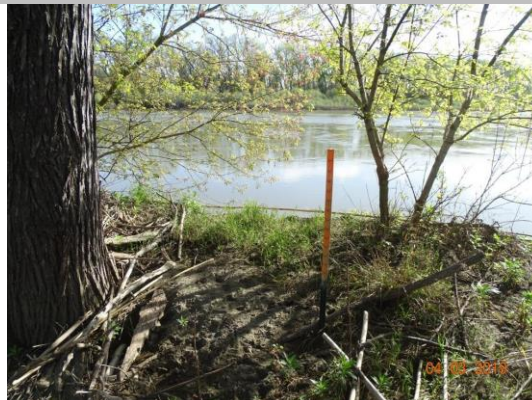
Photo 1 of 5 : SP_2020_NA0016_435_114_20200228_00043.jpg

LM Start	35.26	Rating **	A/W	Issue No.	114
LM End	35.29	Issue Type +	Ma	Location *	WS
Category	Earthen Levee			GPS Latitude/Longitude	
				Start	End
Item	Erosion / Bank Caving			39.099746 °	39.100122 °
				-121.904555 °	-121.904658 °
DWR ID	DWR_NA0016_01_s_2019_114				
Comment Code					
E1 : Note and monitor erosion site.					
Inspector Comment					
Erosion on the waterside berm reported during 2018 storms. Approximately 45' from the bank to the waterside toe is left. Recommend monitoring.

View of the downstream stake on the waterside berm. Spring 2019.

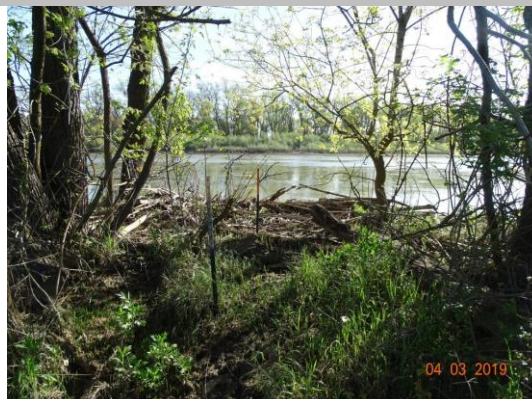
Photo 2 of 5 : SP_2020_NA0016_435_114_20200228_00044.jpg

View of the middle stake on the waterside berm. Spring 2019.

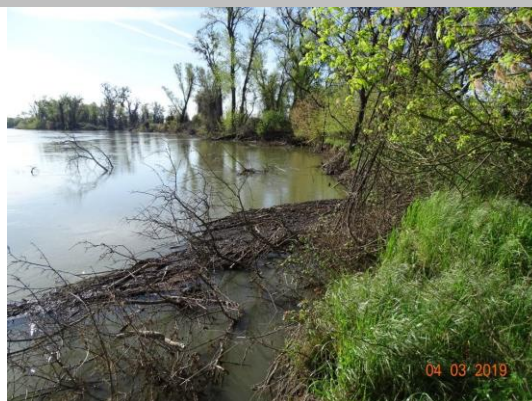
Photo 3 of 5 : SP_2020_NA0016_435_114_20200228_00045.jpg

View of the erosion site facing downstream. Spring 2019.

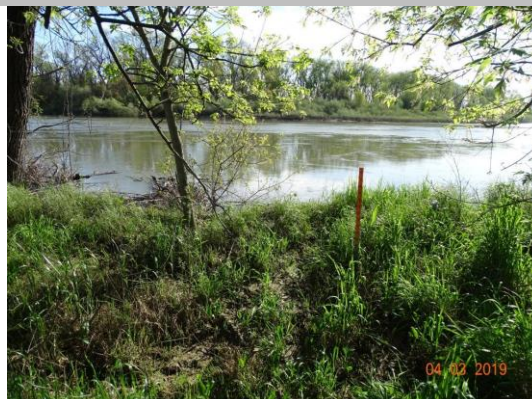
Photo 4 of 5 : SP_2020_NA0016_435_114_20200228_00046.jpg

View of the upstream stake on the waterside berm. Spring 2019.

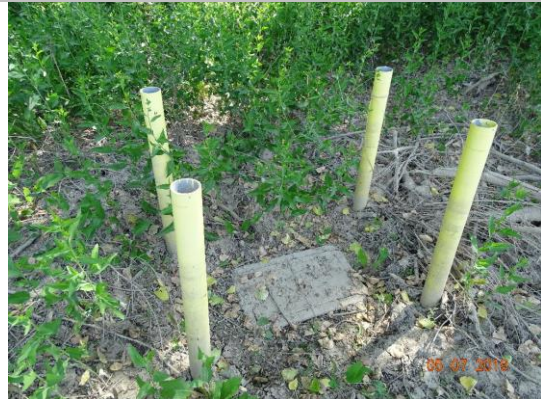
Photo 2 of 3 : UCIP_SP_2020_54161_79767.jpg

Utility box at estimated location of pipe connection

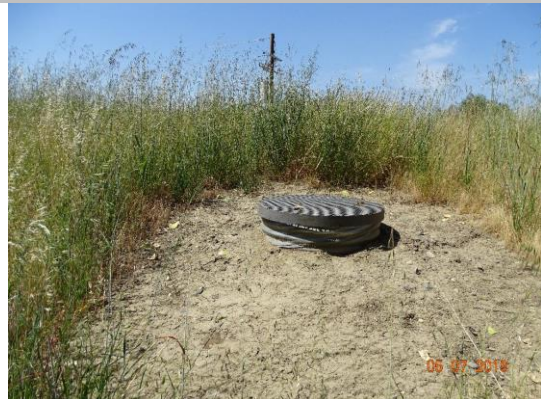
Photo 3 of 3 : UCIP_SP_2020_54161_79768.jpg

CMP riser at WS shoulder

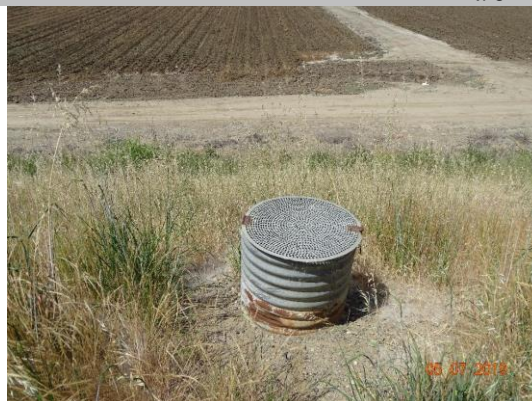
Photo 1 of 2 : UCIP_SP_2020_54162_79772.jpg

Comment Code						
Inspector Comment						
DS_ID:20273 FS_ID:54162 EP_NO: 9364A Repair Type: Non-Urgent Crossing Status: Indicator Found UCIP Comments: 05/07/2019 Crossing looks abandoned. Should be removed or abandoned properly. (O.Yakimov - DWR UCIP)03/18/2013 Need to verify type of abandonment. FIELD_STRUCT_DESC: 3 of 4: 18-inch steel irrigation pipe through the levee, 16 feet below the crown. Metal cutoff wall. Gate valve on the waterside (WS) bank. Siphon breaker in a 24-inch corrugated metal riser unit on the landside (LS) shoulder. (Automatic Board Order (ABO) issued as Permit No. 9364-A, 1974 - Alice Steidlmayer). [Additional Reference(s): DWR Levee Log, 2006. USACE Sacramento O&M Manual 131, May 1960 (HLM 36.04)]. FS Date: 5/7/2019 3:05:52 PM

Siphon breaker in 24-inch CMP riser on LS shoulder

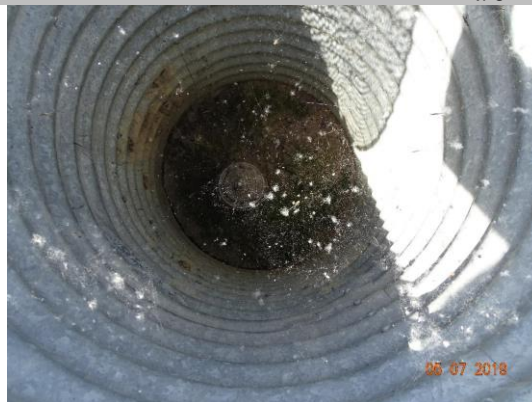
Photo 2 of 2 : UCIP_SP_2020_54162_79771.jpg

View inside of CMP riser

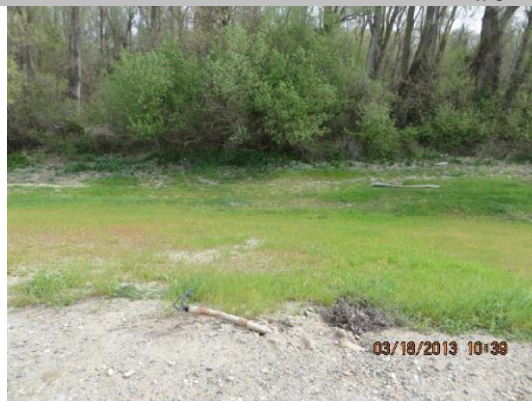
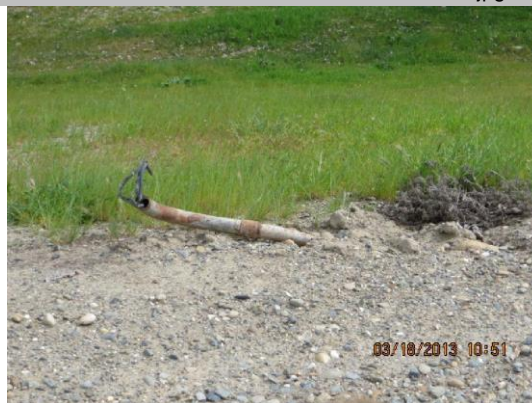
LM Start	35.56	Rating **	M	Issue No.	1638
LM End	35.56	Issue Type +	En	Location *	
Category	Supplemental			GPS Latitude/Longitude	
				Start	End
Item	DWR UCIP Field Study			39.103533 °	39.103533 °
				-121.906814 °	-121.906814 °
DWR ID	20398				
Comment Code					
Inspector Comment					
DS_ID:20398 FS_ID:54163 EP_NO: 9364 Repair Type: Non-Urgent Crossing Status: Found UCIP Comments: 05/07/2019 Needs to be removed from the levee. (O.Yakimov - DWR UCIP)03/18/2013 Remove abandoned pipe from levee. FIELD_STRUCT_DESC: *ABANDONED* 4 of 4: 1.25-inch electrical conduit of an unknown material through the levee, 3 feet below the crown. (Automatic Board Order (ABO) issued as Permit No. 9364-A, 1974 - Alice Steidlmayer). FS Date: 5/7/2019 7:46:31 AM

Electrical conduit on WS shoulder

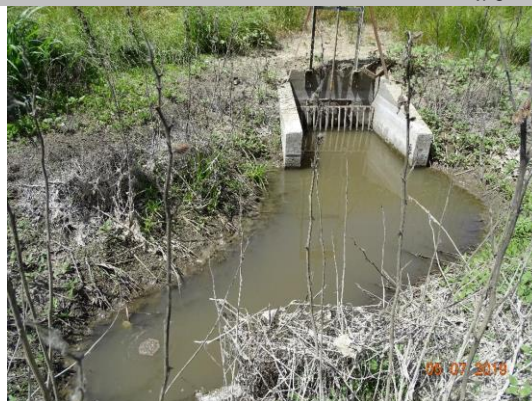
Photo 1 of 3 : UCIP_SP_2020_54164_79775.jpg

DS_ID:20345
FS_ID:54164
EP_NO: 9374
Repair Type: Non-Urgent
Crossing Status: Found
UCIP Comments: 05/07/2019 Pipe is capped on LS approximately 15 feet from LS toe. Minor water leakage observed around capped pipe. (O.Yakimov - DWR UCIP)03/18/2013 Verify if pipe is abandoned with landowner and remove or abandon properly if necessary.
FIELD_STRUCT_DESC: *ABANDONED* 3 of 3: 24-inch concrete encased steel drainage pipe through the levee, 17 feet below the crown. Slide gate on concrete headwall on waterside (WS) end. Walkway to control gate and gate valve on landside (LS) end. (24-inch pipe [HLM 36.61] authorized under Automatic Board Order (ABO) issued as Permit No. 9374, 1974 - Richard H. Moore). [Additional Reference(s): USACE Sacramento O&M Manual 131, May 1960 (HLM 36.61)].
FS Date: 5/7/2019 8:40:51 AM

Outlet/inlet on WS toe

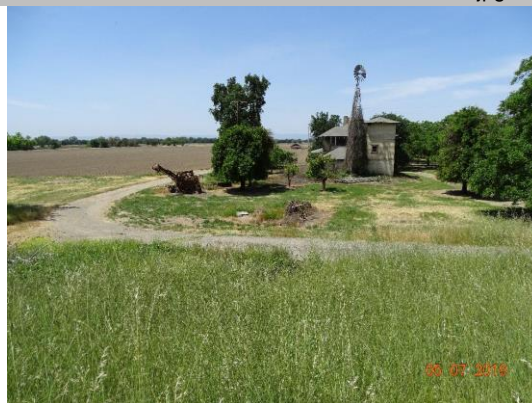
Photo 2 of 3 : UCIP_SP_2020_54164_79776.jpg

LS levee slope

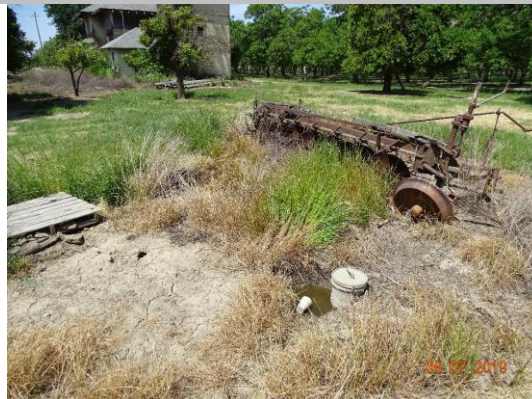
Photo 3 of 3 : UCIP_SP_2020_54164_79777.jpg

Water leaks around capped pipe on LS

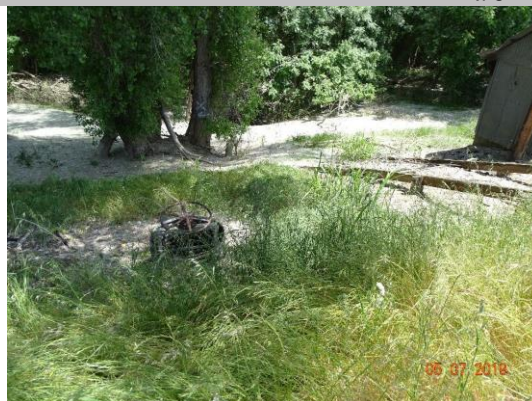
Photo 1 of 3 : UCIP_SP_2020_54166_79779.jpg

View of WS slope

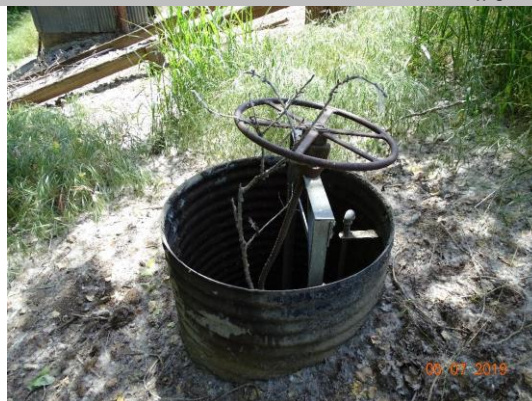
Photo 2 of 3 : UCIP_SP_2020_54166_79780.jpg

CMP riser on WS slope with inopeable slide gate

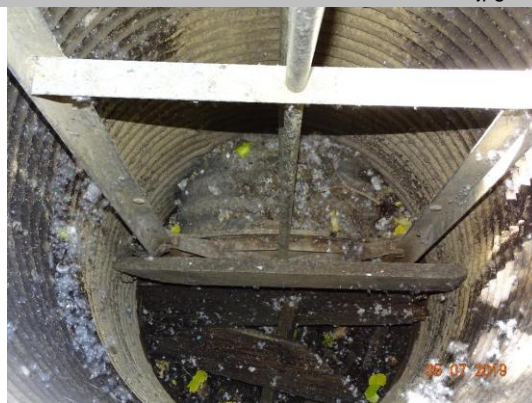
Photo 3 of 3 : UCIP_SP_2020_54166_79781.jpg

View inside of CMP riser on WS slope

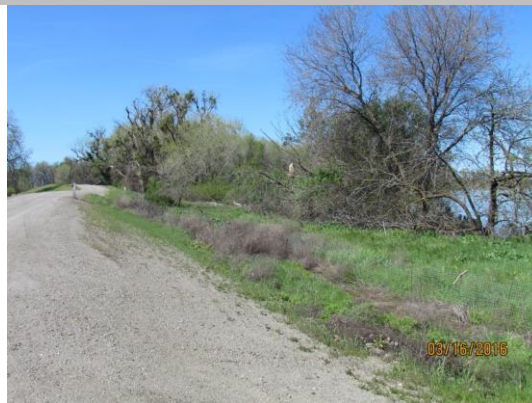
Photo 1 of 2 : SP_2020_NA0016_435_33_20200228_00012.jpg

LM Start	37.07	Rating **	A/W	Issue No.	33
LM End	37.15	Issue Type +	Ob	Location *	WS
Category	Earthen Levee			GPS Latitude/Longitude	
				Start	End
Item	Vegetation			39.121003 °	39.121547 °
				-121.919888 °	-121.921278 °
DWR ID	DWR_NA0016_01_s_2012_33				
Comment Code					
V8 : Environmental Requirements.					
Inspector Comment					
Revegetation site is fenced off.

View of the revegetation site on the waterward berm of the levee looking upstream. Spring 2016.

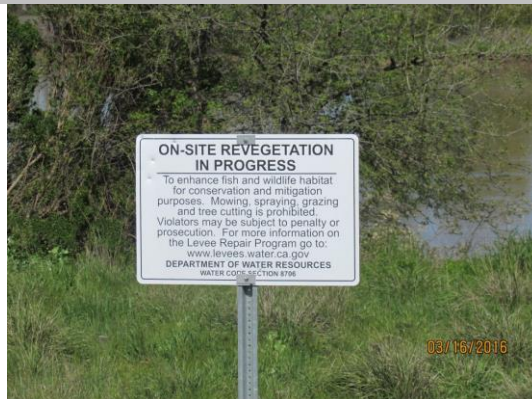
Photo 2 of 2 : SP_2020_NA0016_435_33_20200228_00013.jpg

Sign stating the revegetation site. Spring 2016.
